**Photos of Paulina Creek Flood Features**  
Deschutes National Forest, Bend-Fort Rock District

July 20, 2017

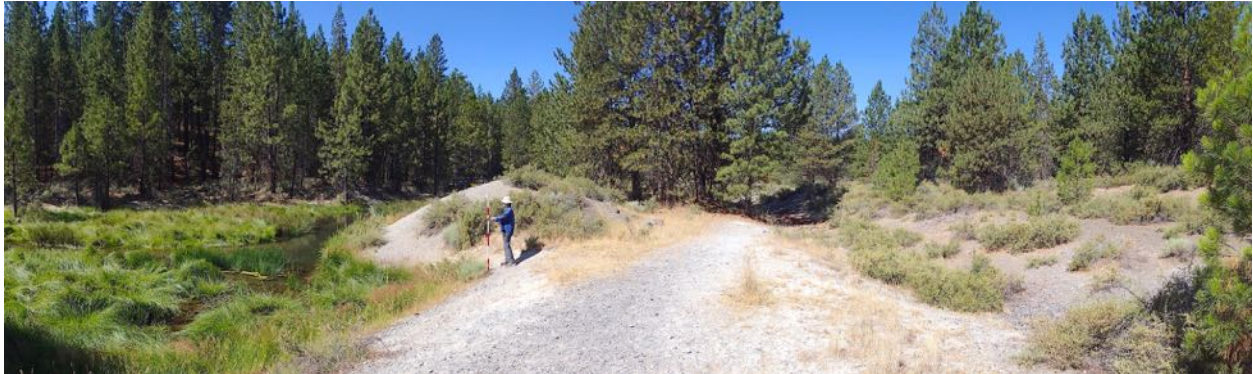
At Ogden Group Camp, where the creek meets the prairie, long gravel bars were deposited, 6-8 feet high.

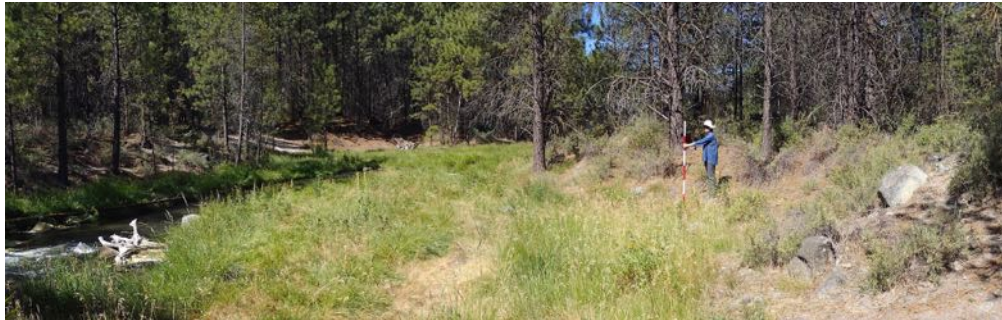
Boulders up to 3' in diameter were embedded in the gravel bars and scattered across the floodplain.

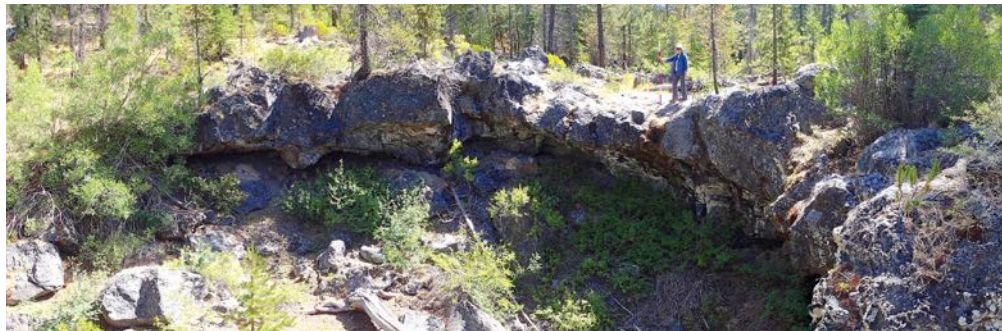
Five miles upstream is a huge, abandoned dry waterfall, scoured out by the cataclysmic flood.

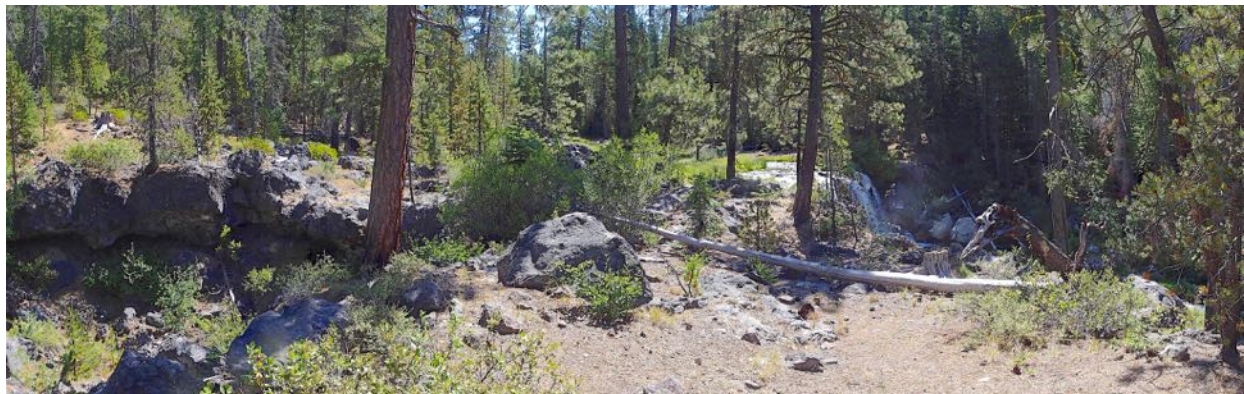
Paulina Creek today (at right) flows over a small waterfall just to the south of the huge dry falls (at left).

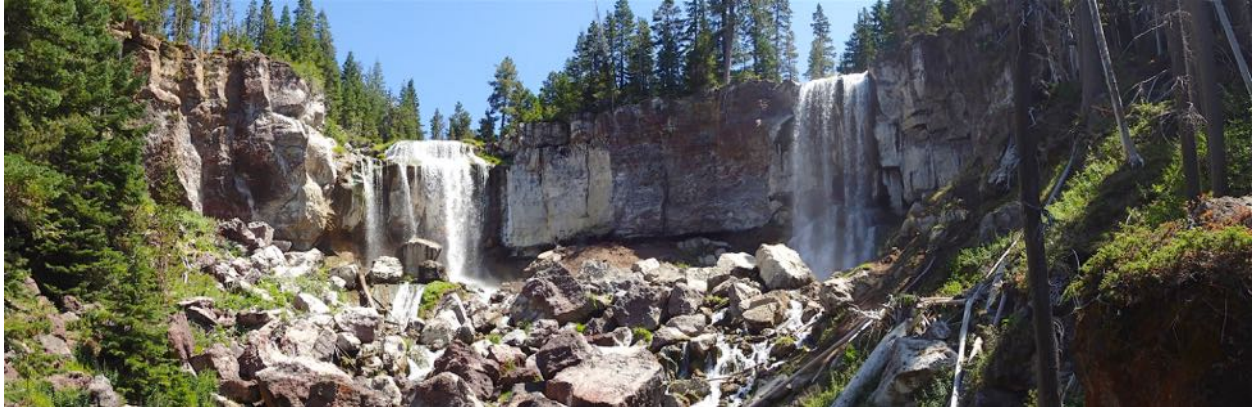
Paulina Falls today continues to migrate toward the lake, just like the original falls that created the flood.

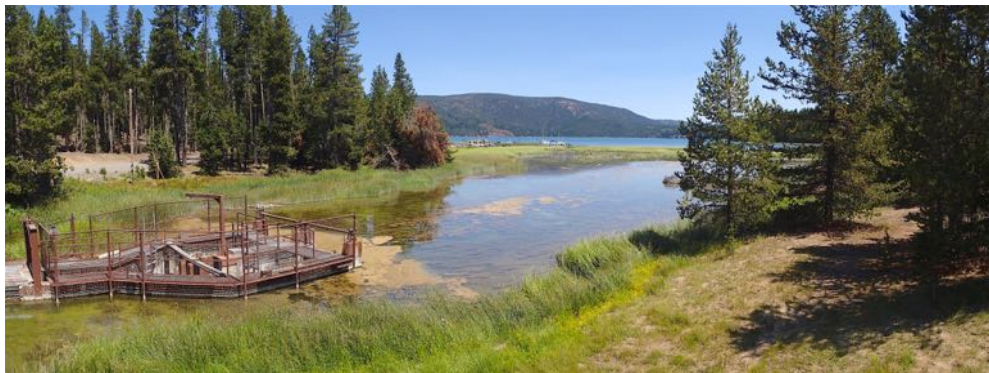
The modern-day outlet of Paulina Lake is protected by a concrete dam and fish screen...

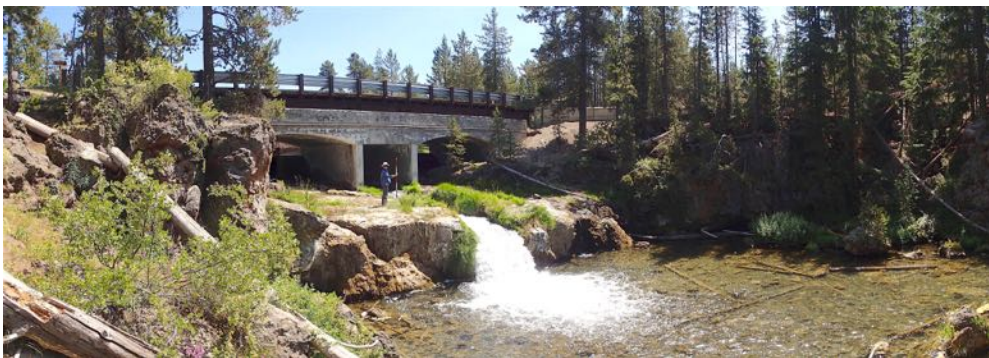
...but just below the dam, the stream is slowly eroding away the rock sill holding up the lake.

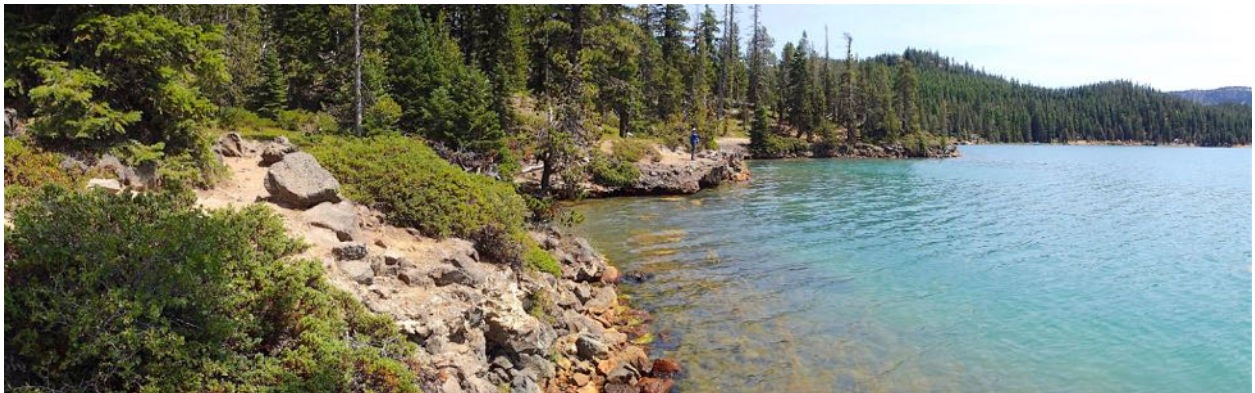
A wave-cut terrace several feet above the modern lake level records the sudden failure of the outlet sill.
